CRITICAL INDUSTRY REPAIR ANALYSIS FOOD INDUSTRY

CONTRACT OCD-OS-62-257
OCD SUBTASK NUMBER 3311A
REPORT NUMBER CIRA-3
APRIL, 1965

CRITICAL INDUSTRY REPAIR ANALYSIS

FOOD INDUSTRY

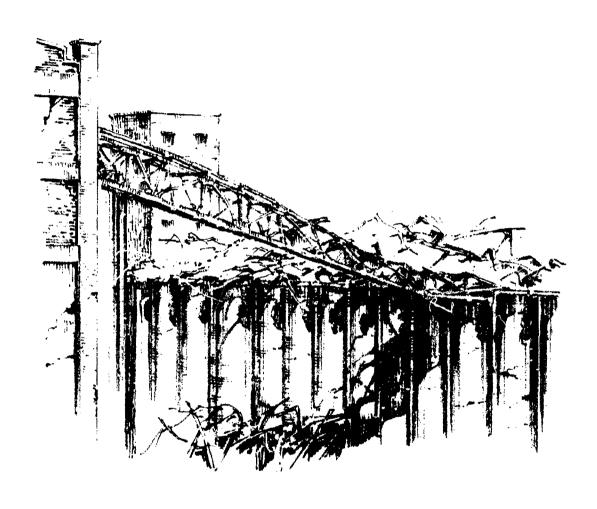
Damage to Corveyor Bridge at Flour Mill at 2.5 psi Overpressure Figure 2-9 reconstruction are required. Repair work and time involved will delay process operation for a long period of time. This range ends at the point where plant failure is so extensive that repair is not economical and the plant should be abandoned or rebuilt.

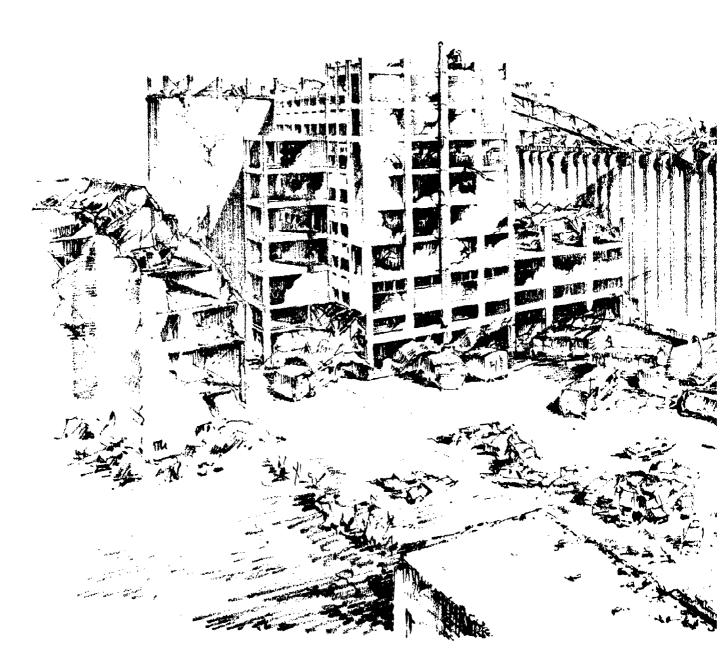
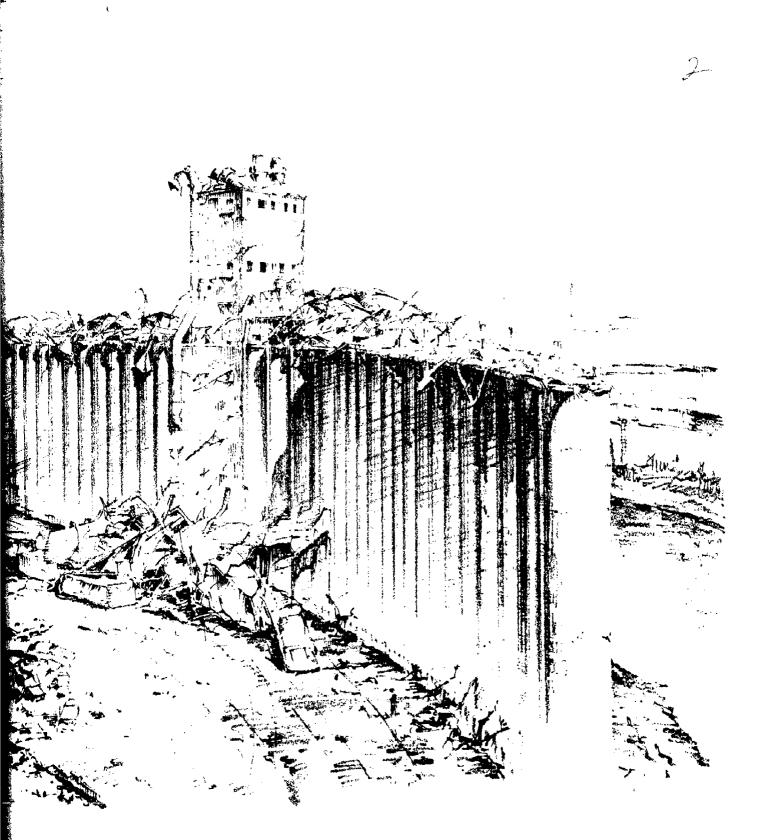
Figure 2-10 2-24

age to Flour Mill at 5 psi Overpressure

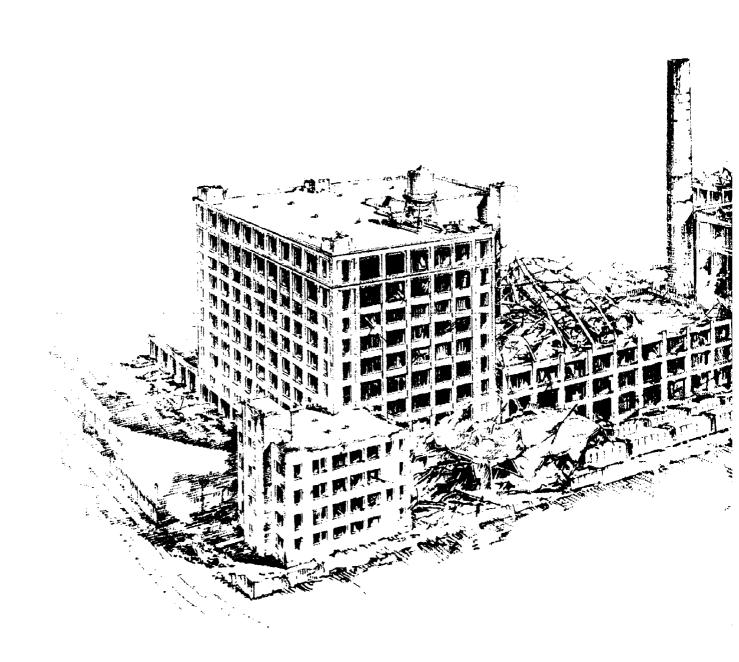
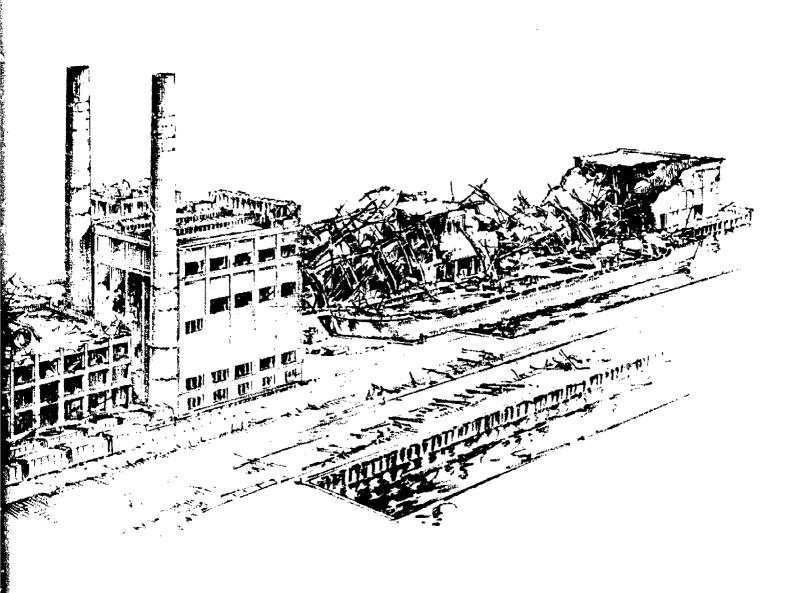
The north wall, which is without windows, will suffer some cracking at 3.5 psi, but damage will not extend to the frame. Other sides have more than 50 percent windows and will fail at much higher overpressures. The two water tanks on the roof of the panhouse, supported on a single set of columns, are primarily drag structures and would be subject to overturning, if empty, at 4.0 psi. If partially filled, however, their stability becomes greatly improved because the additional mass of the water improves the resistance to overturning, while tending to decrease the natural frequency and reduce the rate of dynamic response. If full, the failure criterion is column buckling of the supporting legs, which would occur at 6.5 psi. The tanks are normally kept full, and therefore failure in the last-named mode can be expected.

to Sugar Refinery at 3 psi Overpressure

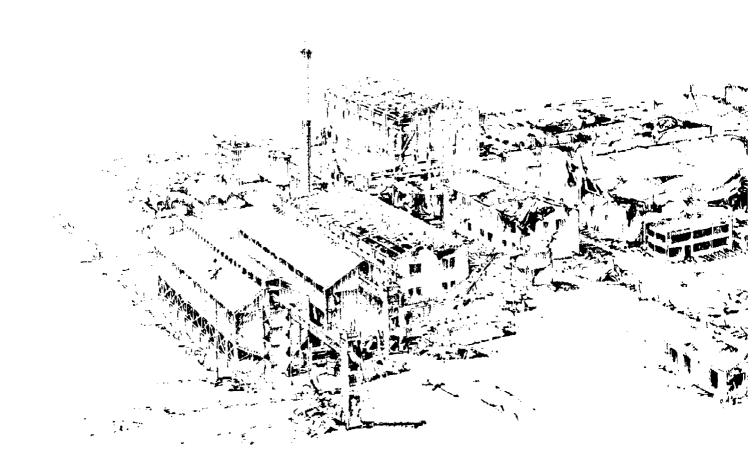
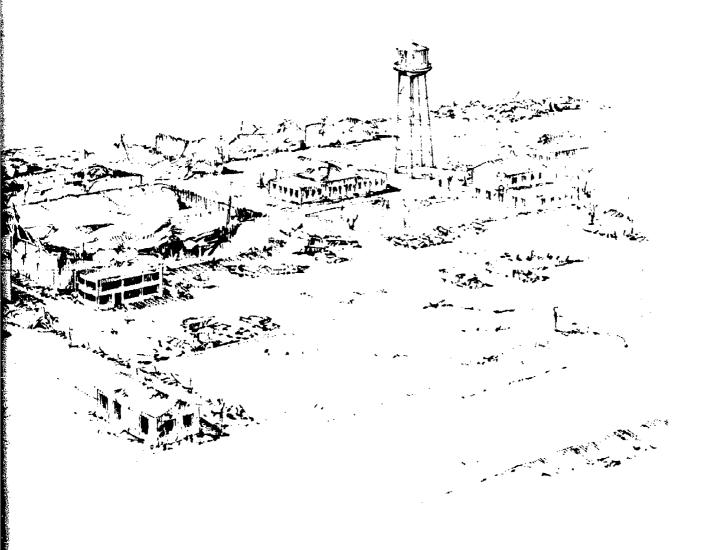
trus Juice Plant at 4 psi Overpressure

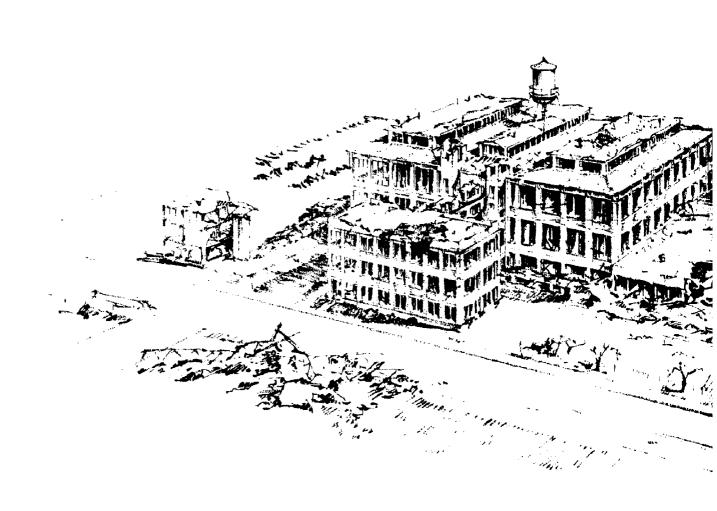
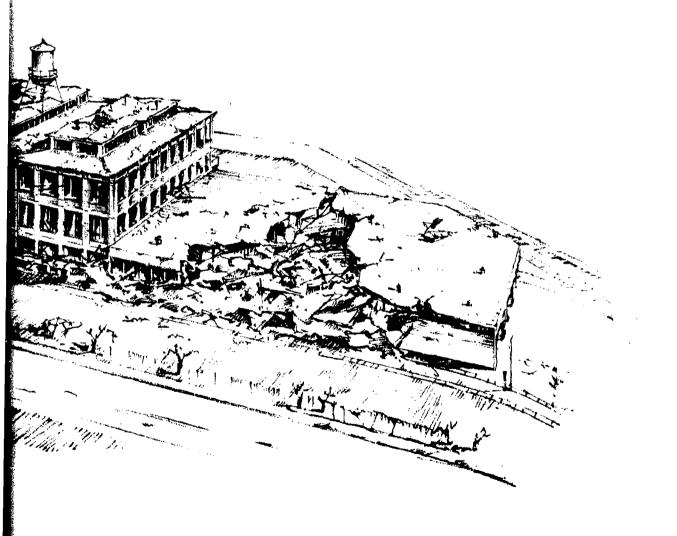
Although all of these buildings may not fail simultaneously, the frames of the warehouse, boilerhouse and office building will collapse when overpressures approach 7.0 psi. The collapse of the warehouse frame will increase the damage to packaging equipment; boilers as well as motors and other fairly heavy equipment will be severely damaged. The office building and its equipment will be completely destroyed.

Metal-Container Plant at 7 psi Overpressure

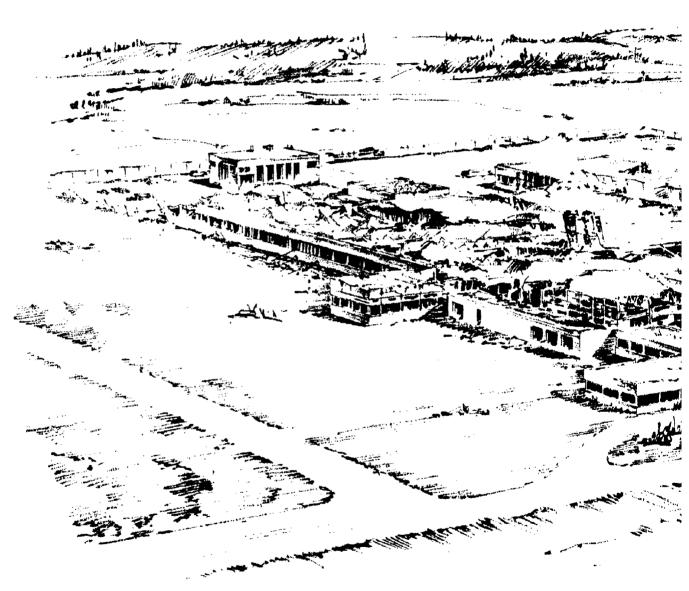
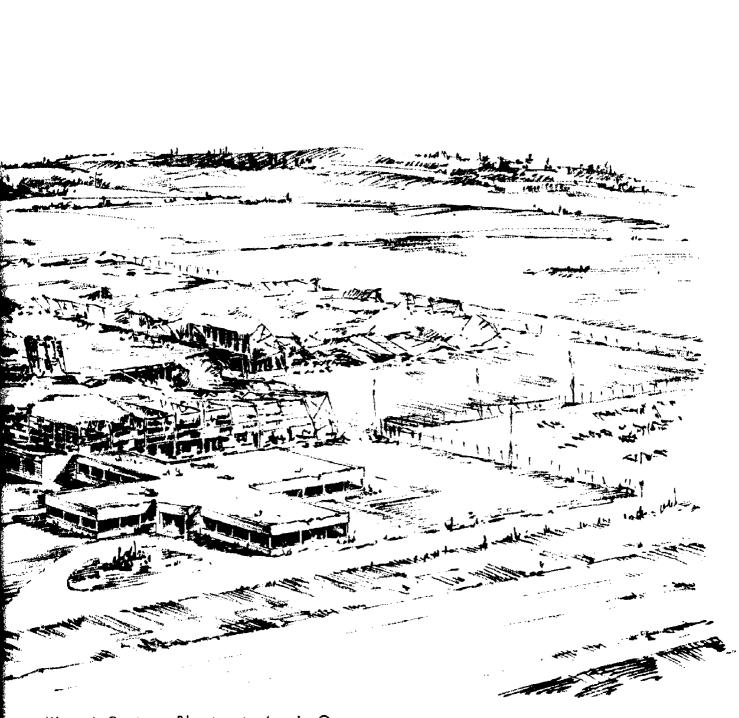
to Waxed-Carton Plant at 4 psi Overpressure

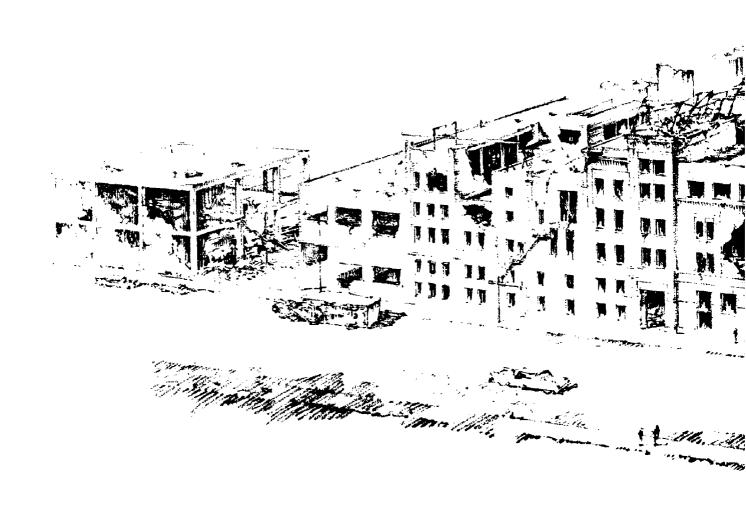
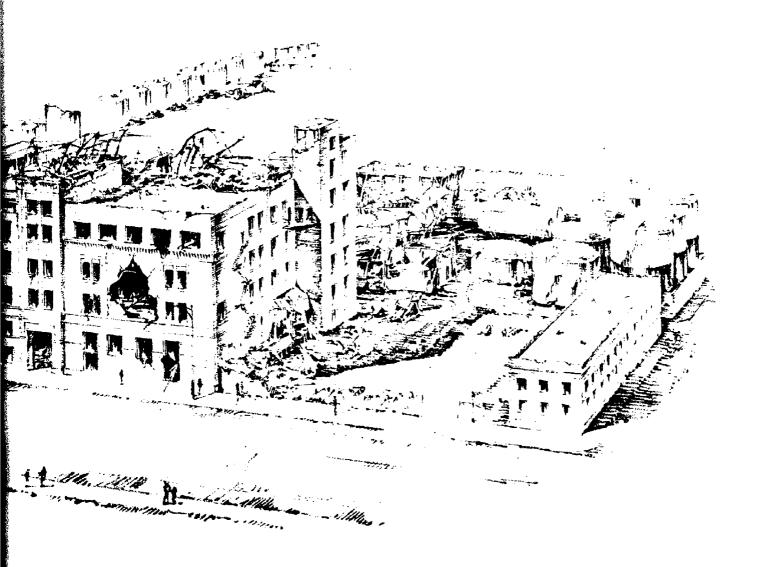
to Edible-Oils Plant at 7 psi Overpressure
